Nondestructive Inspection and Evaluation of Composite-Material Flywheels—Volume 2

K. L. Reifsnider

Lawrence
Livermore
National
Laboratory

Volume 1 describes the nondestructive investigation (NDI) of various prototype composite flywheels before the proof-of-concept burst tests were conducted. Volume 2 presents a discussion of various NDI techniques and their applicability to composite materials and flywheels. Results of nondestructive evaluation (NDE) to assess damage accumulation in composite-material flywheels which were subjected to loading cycle(s) at rotational speeds below the expected burst speeds are also given in Volume 2.

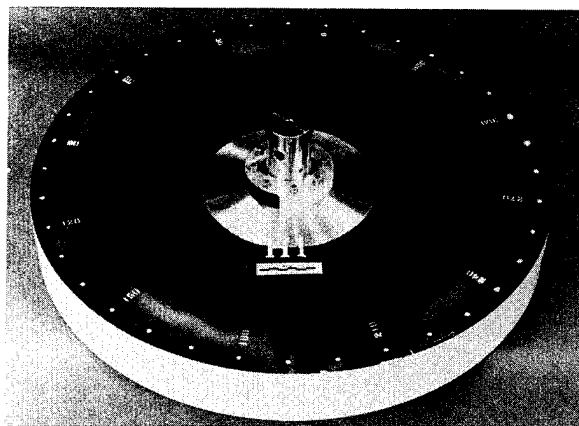
Figure 1. (a) Graphite/polysulfone filament-wound contoured rim (Hercules design). (b) Radiograph of Hercules flywheel showing three low-density rings. (c) Photograph from video recording of Hercules rotor during spin testing showing circumferential cracking in rim.

Obtaining an x-ray radiograph, such as the one shown in Fig. 1(b), requires some trial and error even for experienced operators. When a

Fig. 1(b) the x-ray beam was parallel to the rotation axis of the flywheel. The discontinuities were also in the same plane. The circumferential cracks that formed during the spin test were also in that plane and extended through the thickness of the flywheel. Cracks or other defects in the plane of the flywheel would not be resolved by such an arrangement unless there were regions of significant depth in the direction of the incident x-ray beam.

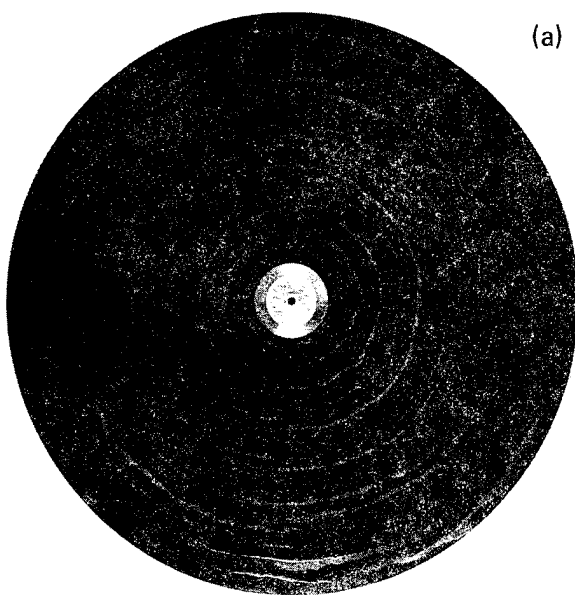
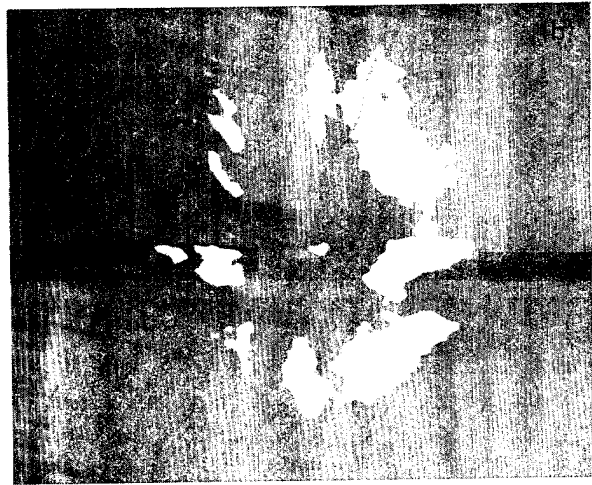
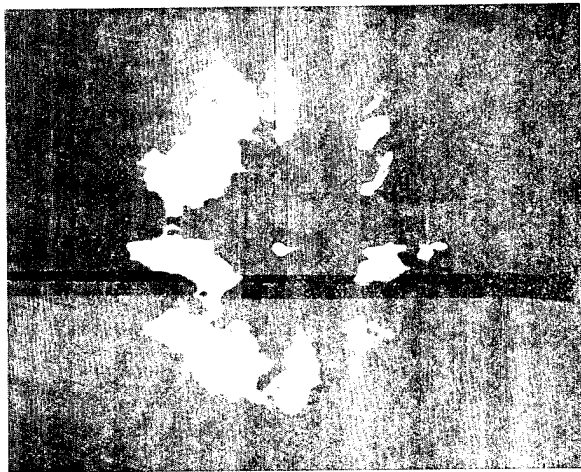
Figure 8. (a) LLNL tapered-thickness graphite/epoxy laminated disk. (b) Ultrasonic C scan of graphite/epoxy panel gating loss of back-surface reflection from front. (c) Ultrasonic C scan of graphite/epoxy panel gating loss of back-surface reflection from back. Note that (b) and (c) are mirror images. (d) Ultrasonic C scan of graphite/epoxy panel gating internal scattering from front. (e) Ultrasonic C scan of graphite/epoxy panel gating internal scattering from back. Note that (d) and (e) do not show as mirror images.

Laminated composite panels that were later machined into the required flywheel contour were also ultrasonically inspected. The pulse-echo technique was used for recording the signal information. Ultrasonic C scans were made by measuring the change in back-surface reflection and by gating the signal to measure the internal reflections. Typical C scans of a 1-in.-thick graphite/epoxy panel [from which a tapered thickness contour was subsequently machined (Fig. 8(a))] are shown in Figs. 8(b)–8(e). The panel was $26 \times 26 \times 1$ in. and inspected using a 2.25-MHz transducer. Figures 8(b) and 8(c) show the loss of back-surface reflected amplitude for C scans of the front and back surfaces, respectively. Figures 8(d) and 8(e) are the C scans obtained by gating the internal 2/3 of the panel for front- and back-surface incidence, respectively. In these C scans the dark areas indicate the scatter sites. The outer edges of this panel were nominally thinner causing the recorded signal variation in the C scans for the internal gating situation.

It should be pointed out here that the large defect areas that are evident in Figs. 8(b) and 8(c)
